# U.S. ARMY ENGINEER RESEARCH AND DEVELOPMENT CENTER APT Monthly Webinar Update March 2023

Jeremy Robinson, PE, PhD  
Research Civil Engineer  
[Jeremy.Robinson@usace.army.mil](mailto:Jeremy.Robinson@usace.army.mil)

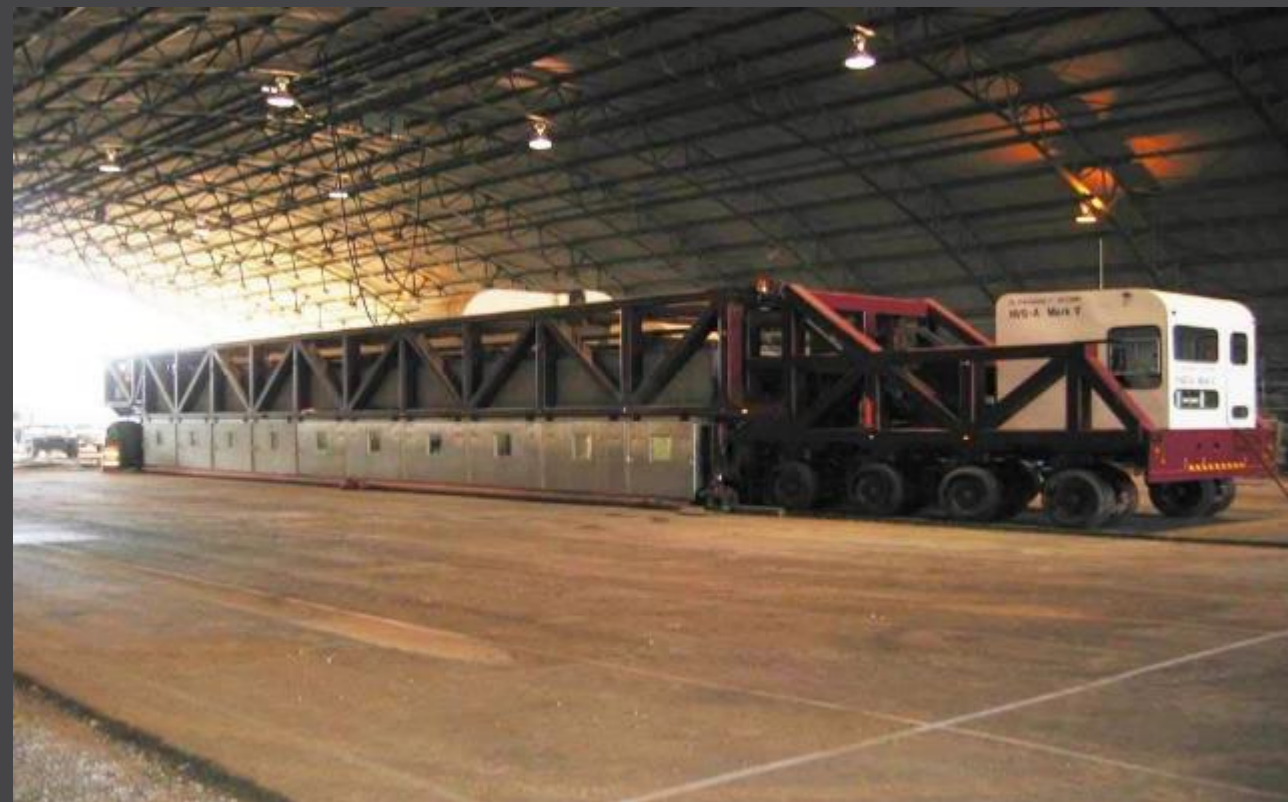
## ■ HVS-A (Bigfoot)

- Length: 119.2 ft
- Width: 16.4 ft
- Mass: 227,000 lbs
- Tracking length: 40 ft
- Wander: 5 ft
- Load: 10,000 – 100,000 lbs
- Speed: 4 – 10 mph
- Environmental: 23°F - 109°F

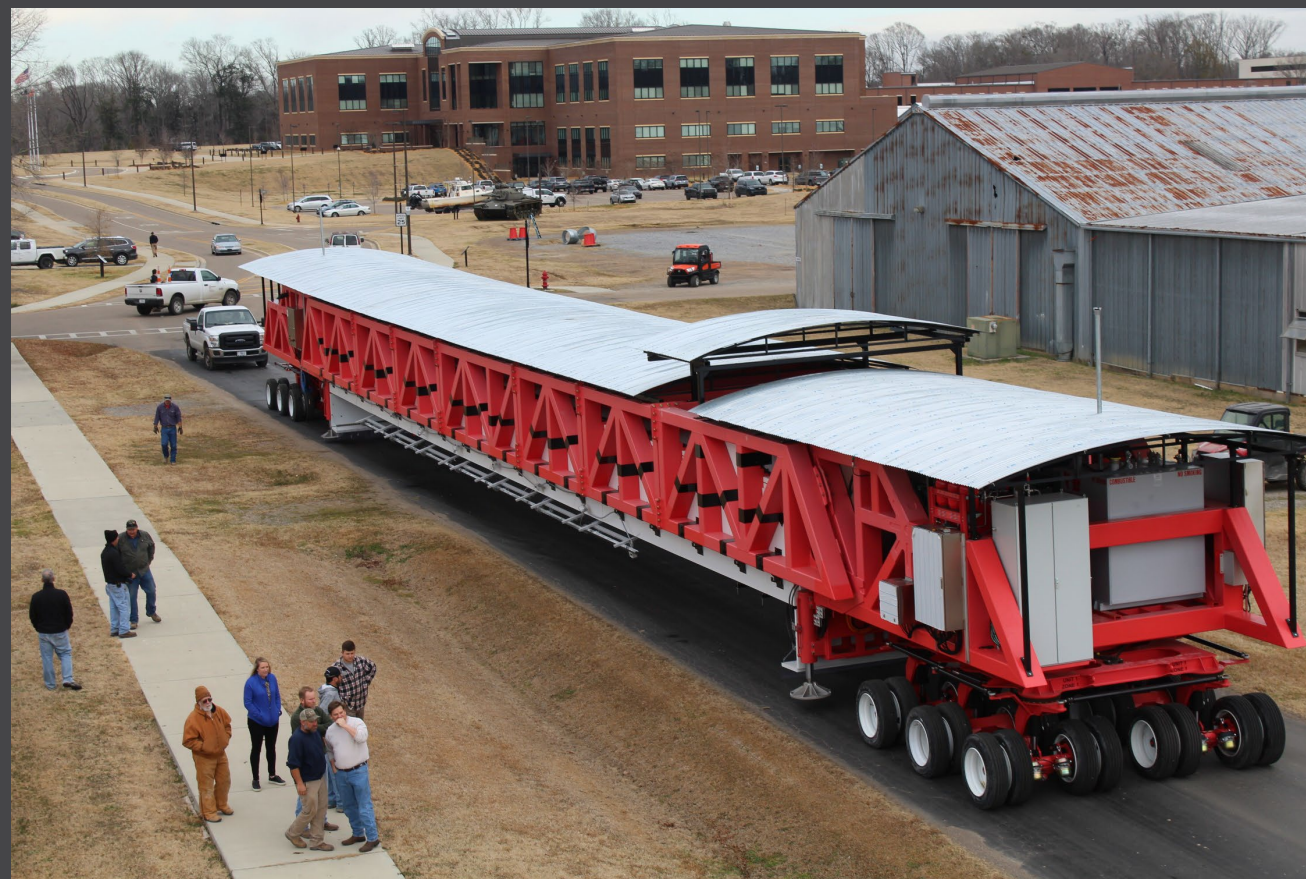
- HVS-T (Titan)
  - Wheel load: 9,000 – 120,000 lbs.
  - Testing length: 70 ft
  - Wander: 6 ft
  - Laser profiler
  - Environmental chamber  
0° F – 110° F
  - Carriage:
    - ▶ Highway
    - ▶ Aircraft
    - ▶ Rail
  - Programmable sink rate
    - ▶ Simulate aircraft touchdown

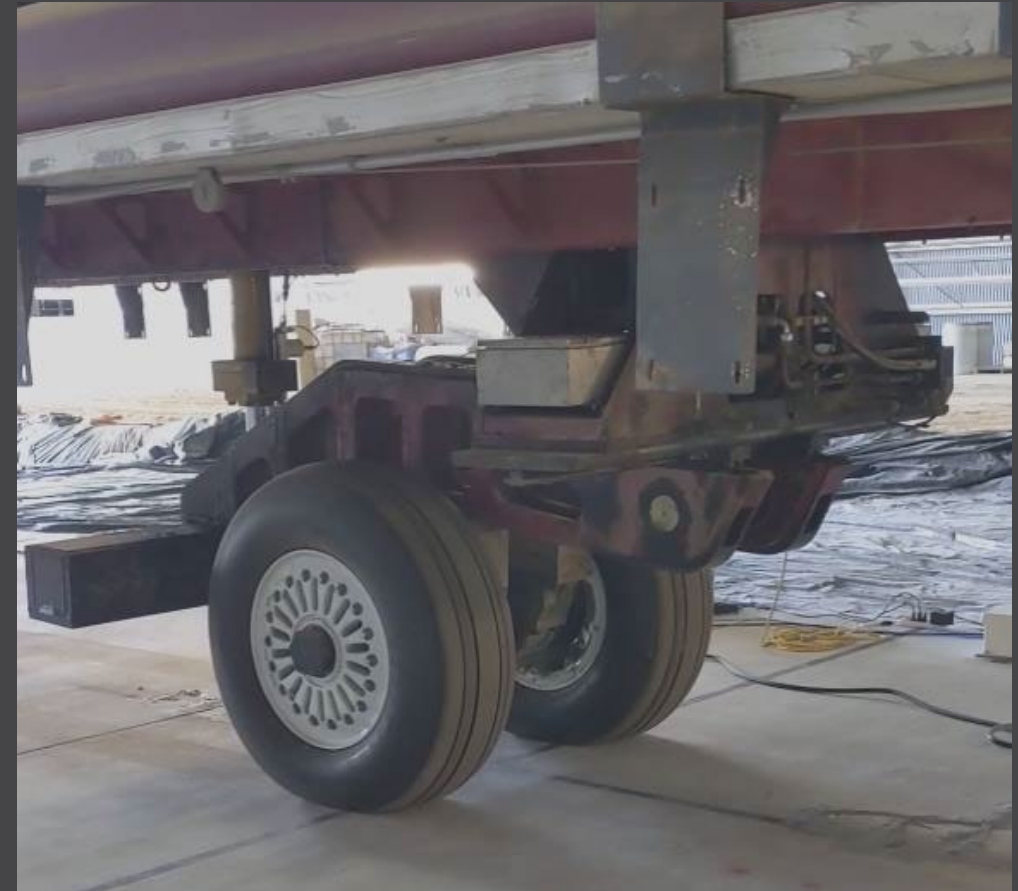
# Structural evaluation for the P-8 Poseidon aircraft

- **Rigid pavement**
  - 8 in., 11 in, 14 in. thick
  - Dowel and undowelled joints
  - Standard PCC mix (650 psi flex)
- **Flexible pavement**
  - 2 in. and 4 in. thick HMA
  - Weak and strong base course
  - 6 and 10 CBR clay subgrade
- **AM-2 matting**
- **Airfield Damage Repair (ADR)**

- **89,000 lb total load**
- **220 psi inflation pressure**
- **8-ft wide wander (outside to outside)**

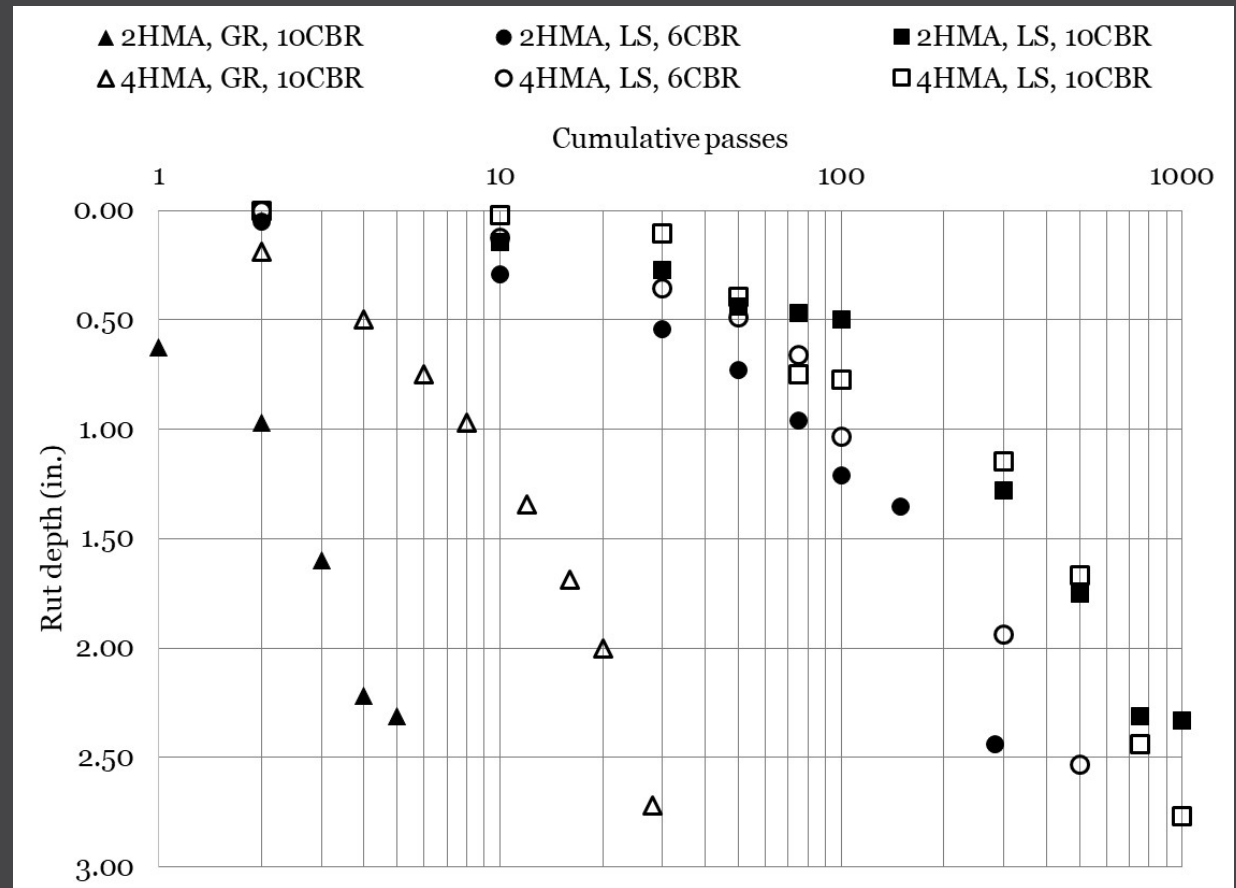
# Flexible pavement testing

- **HMA Thickness**
  - Increase in HMA thickness improved rutting performance on weaker subgrade
  - Not meaningful on firm subgrade
- **Base Course Strength**
  - Increase in base course strength significantly improved rutting performance
  - Highlighted importance of competent base layer
- **Subgrade Strength**
  - Increase in subgrade strength improved rutting performance

Passes to rut	Rut depth (in.)								
	0.25	0.5	0.75	1	1.25	1.5	2	2.5	
2HMA, GR, 10CBR	1	1	1	2	3	3	4	7	
4HMA, GR, 10CBR	2	4	6	8	11	14	20	26	
2HMA, LS, 6CBR	9	27	52	79	114	168	230	290	
4HMA, LS, 6CBR	21	52	81	99	148	203	321	489	
2HMA, LS, 10CBR	27	100	180	260	292	356	611	833	
4HMA, LS, 10CBR	40	57	75	222	340	436	608	797

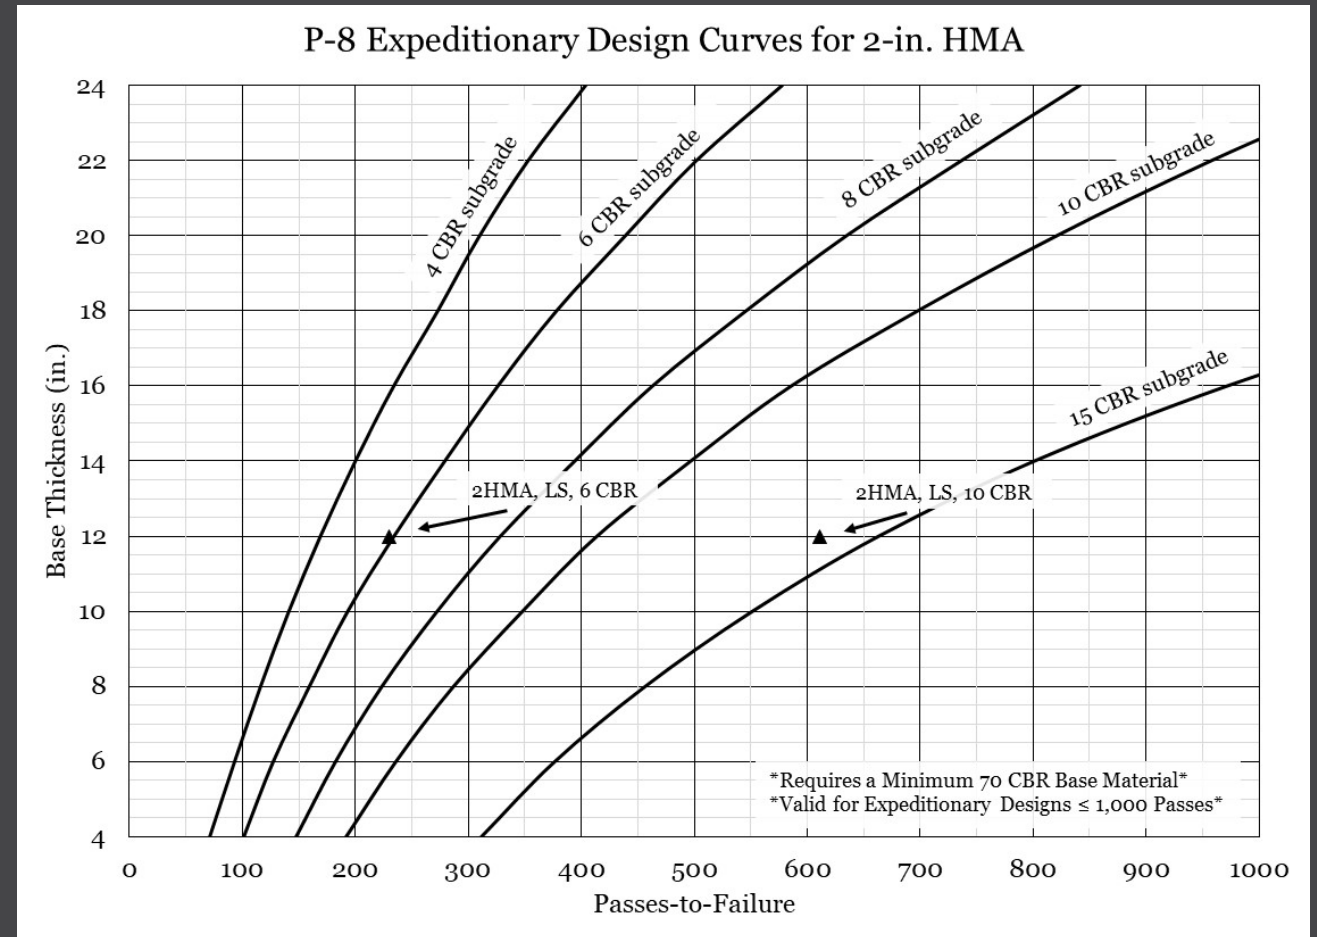
# Flexible pavement contingency design curves

- Developed design curves based on APT observations and analytical effort
- Leveraged MEPDG deformation model
  - Added a modulus deterioration model
  - Added a non-uniform tire loading model
  - Incorporated aircraft wander
- Calibrated model using rutting data, instrumentation response, and NDT data

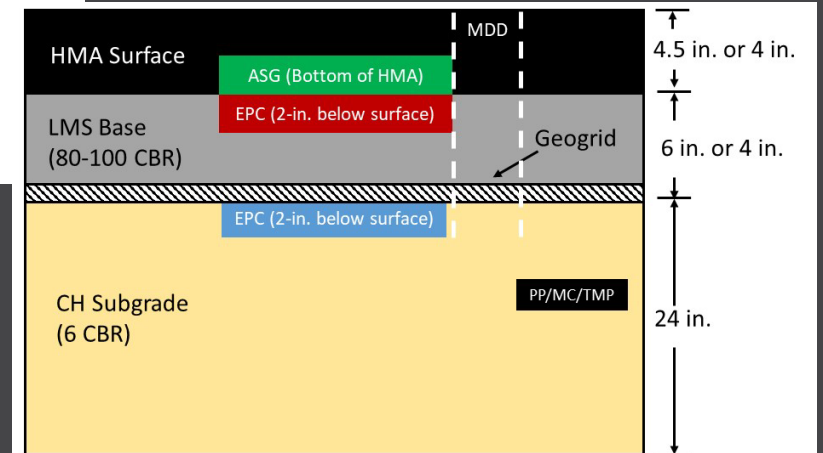
- Full-scale flexible pavement test section
  - 4-in. and 4.5-in.-thick asphalt layer
  - 4-in. and 6-in.-thick crushed limestone aggregate layer
  - 6 California Bearing Ratio clay subgrade
- Three recently developed innovative geogrids
  - Combination of hexagonal, trapezoidal, and triangular aperture shapes
  - Coextruded, composite polymer sheet
  - Punched and oriented
- Geogrids placed at aggregate/subgrade interface

LMS = crushed limestone  
 CH = high-plasticity clay  
 HMA = hot-mix asphalt  
 NOT TO SCALE

EPC = earth pressure cell  
 MDD = multi-depth deflectometer  
 PP/MC/TMP = pore pressure/moisture content/temperature

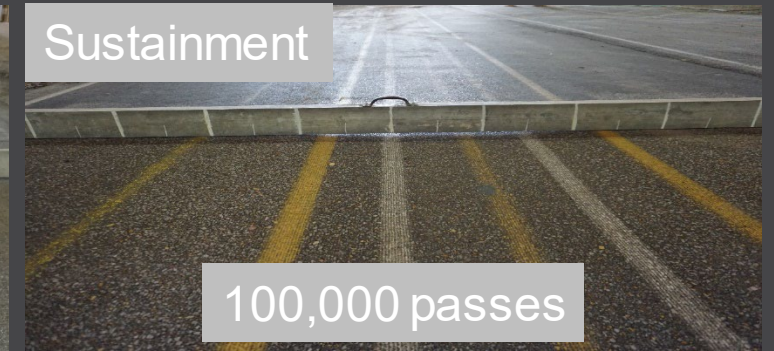
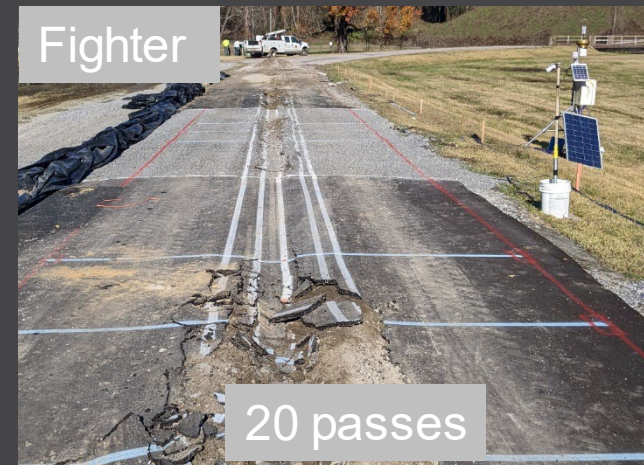
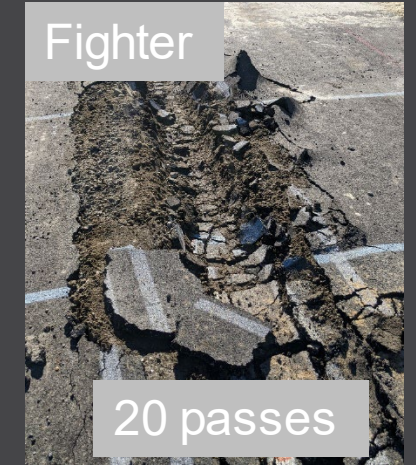
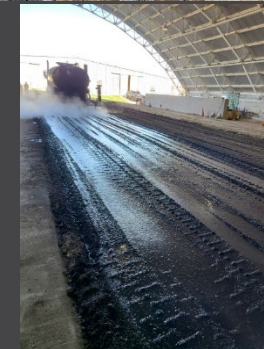
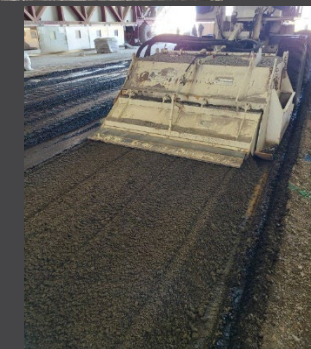
# FDR Pavement Research Projects

- **FDR for Sustainment Operations:**
  - C-17 loading conditions (45 kips/142 psi)
  - Cement and cement/emulsion additive
  - 12-in.-thick reclaimed layer

- 2.5-in.-thick HMA surface
  - Trafficked to 100,000 passes with <1 in. rutting
- **Minimum Surface Thickness for Fighter Aircraft:**
  - F-15 loading conditions (35 kips/325 psi)

- Cement additive
  - 10-in.-thick reclaimed layer
  - Multiple surfaces
    - 4 in., 2 in., and 1 in. HMA layer
    - Double bituminous surface treatment

- Microsurfacing
    - Unpaved
    - Emulsion treatment
- **Evaluation of FDR under P-8 Poseidon Aircraft:**
  - P-8 loading conditions (45 kips/220 psi)

- Emulsion/cement additive
  - 14-in.-thick reclaimed layer
  - 2-in. and 4-in.-thick HMA surface; unpaved test item
- **FDR for Landing Zones:**
  - C-17 (45 kips/142 psi) & C-130 (35 kips/100 psi) loading conditions

- Two material types
    - Silty sand
    - Gravel
  - 12-in.-thick reclaimed layer
  - Unpaved surface

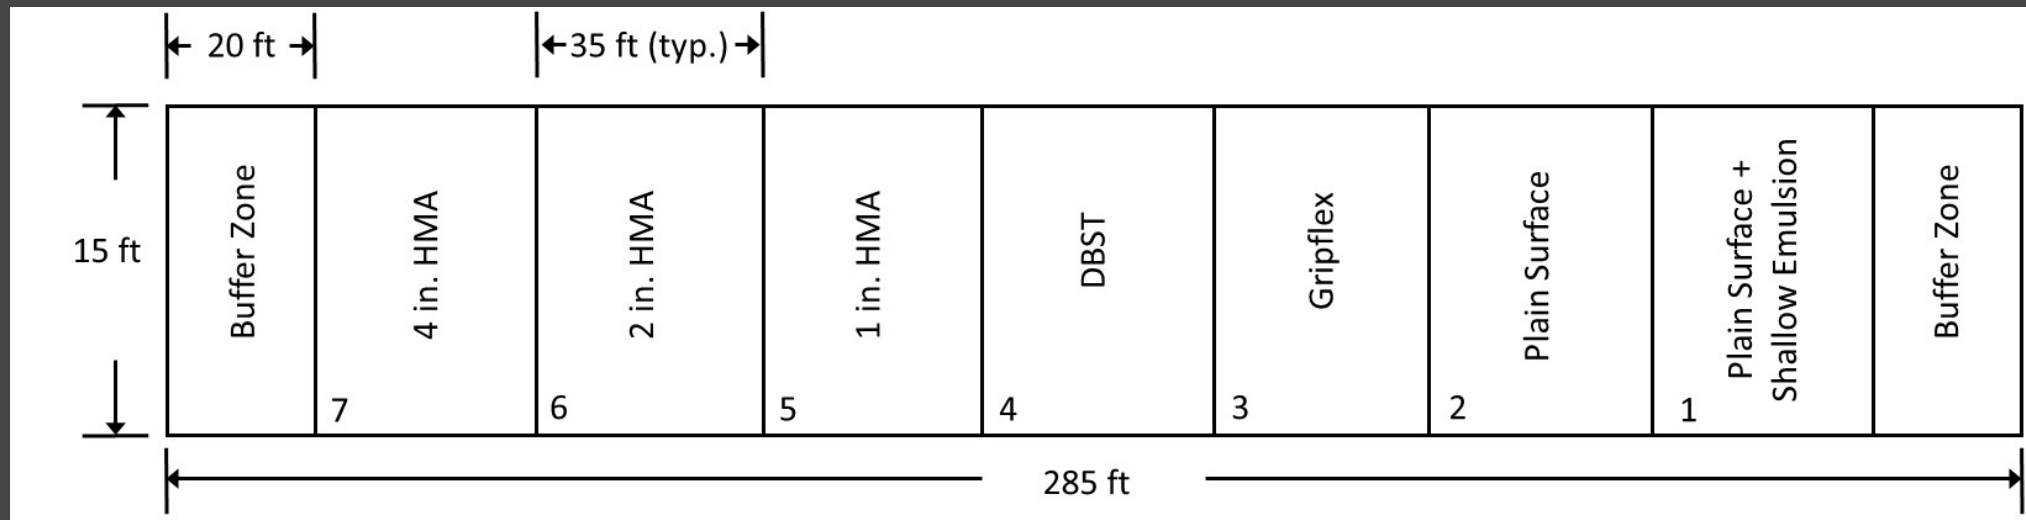
# Effect of Fighter Aircraft Traffic on Full-Depth Reclamation with Thin Surface Treatments

- Assess structural capacity of FDR base layer with a variety of thin surface treatments
  - Cement treatment only (5% cement)
  - Section was trafficked with single-wheel F-15 load cart
    - ▶ 35,000 lb total load
    - ▶ 325 psi tire inflation pressure

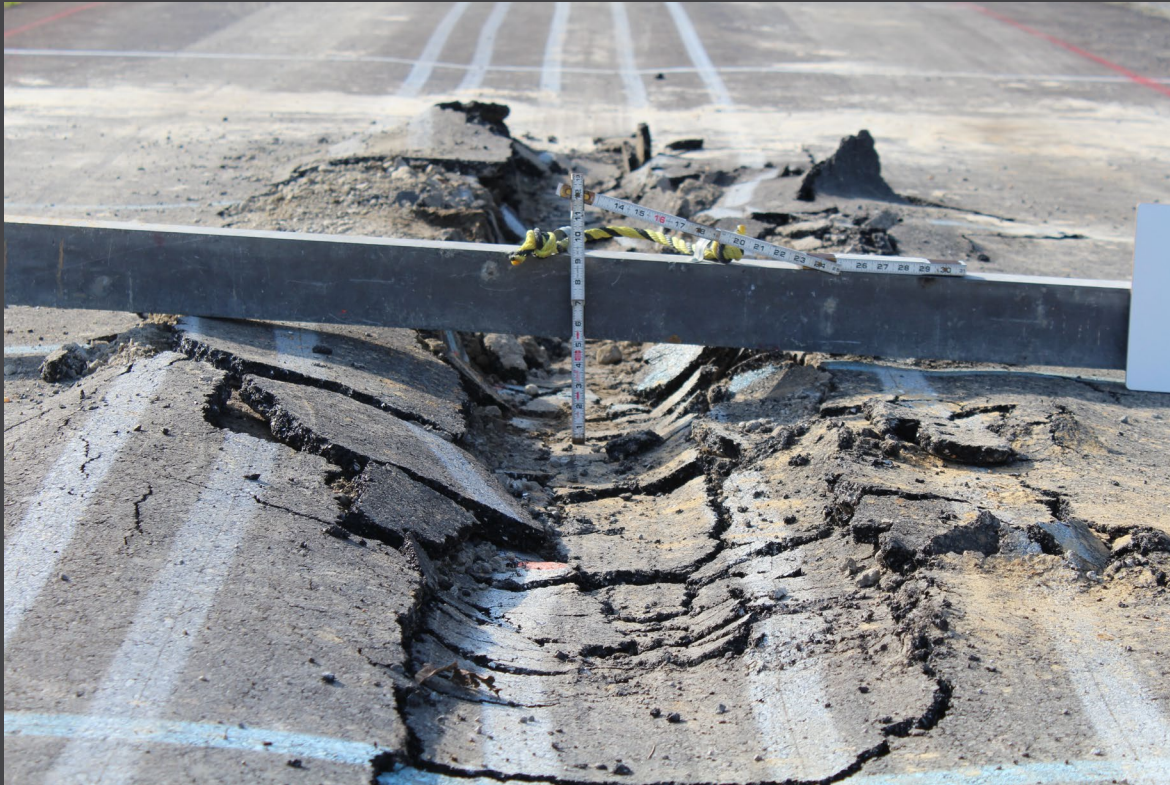
1 in.-thick HMA @ 20 passes

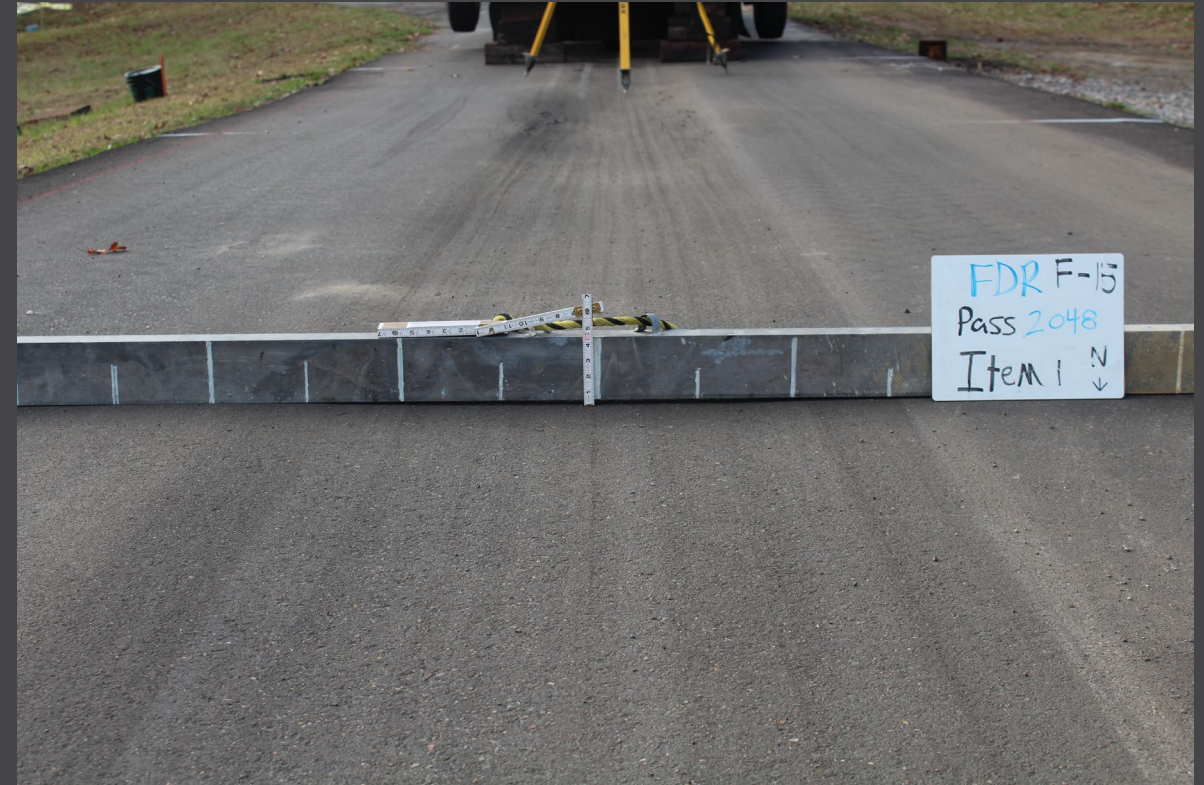
4 in.-thick HMA @ 2,048 passes

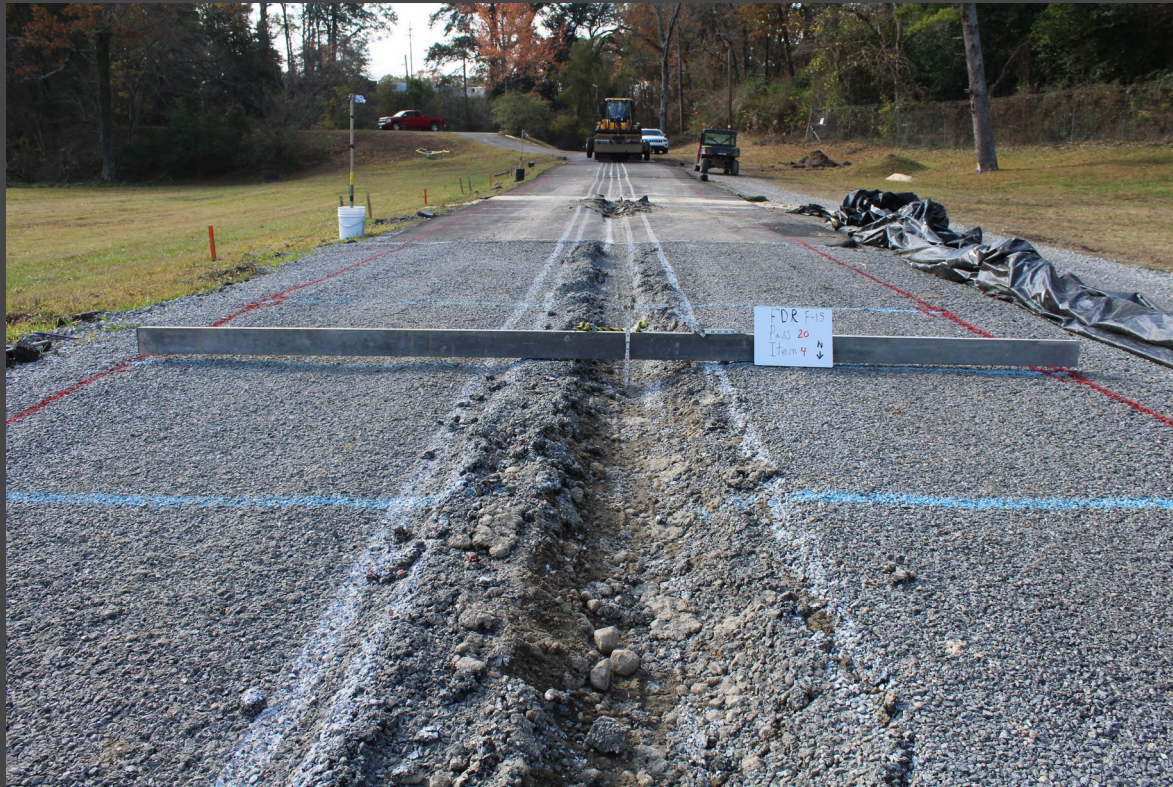
DBST @ 20 passes

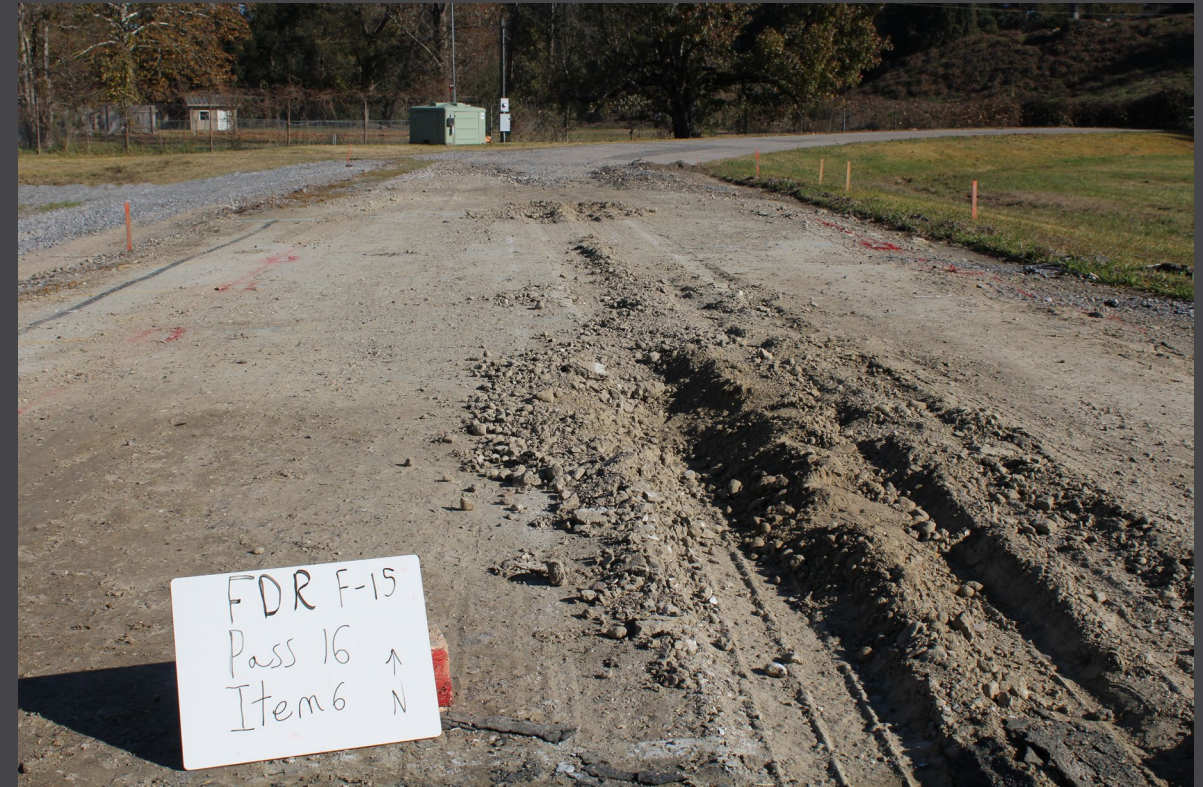
Unpaved @ 20 passes

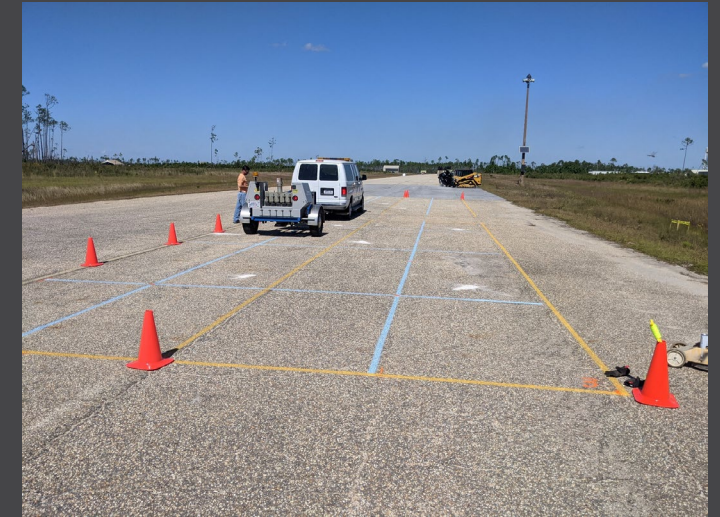
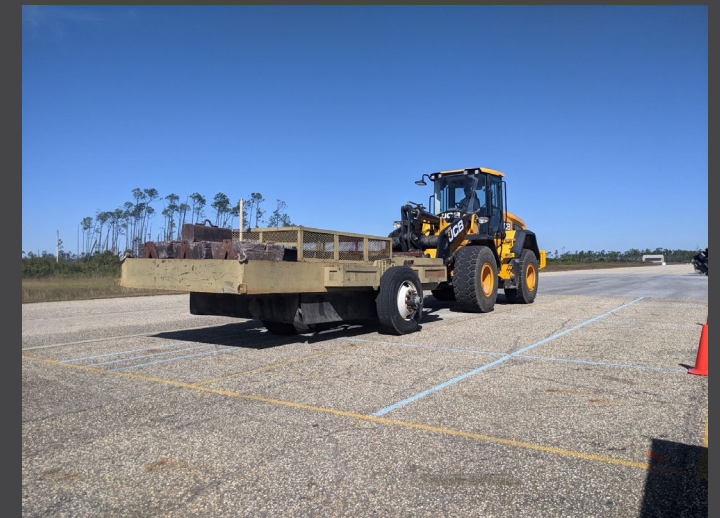
# Evaluation Methods for Non-Traditional Pavement

- **Site 1: Tyndall Air Force Base, Florida**
  - 2-in.-HMA, 6 to 8-in. base, silty sand subgrade (severely oxidized and block cracked)
- **Site 2: ERDC, Mississippi**
  - 1 to 2-in.-HMA, variable base course, CL subgrade
- **Site 3: Eglin, Florida**
  - 7-in.-thick sand asphalt, sand subgrade
- **Site 4: Eglin, Florida**
  - 3.5 to 4-in. HMA, variable base course, sand subgrade
- **Site 5: Malmstrom, Montana**
  - DBST surface, 4-in.-thick base, 58-in. thick subbase, clay subgrade
- **Site 6: Malmstrom, Montana**
  - 3.5-in. HMA, 4 to 6-in. base 58-in. thick subbase, clay subgrade

- Most sites were non-aircraft traffic, i.e. training sites or overruns, thus deterioration was primarily environmental.

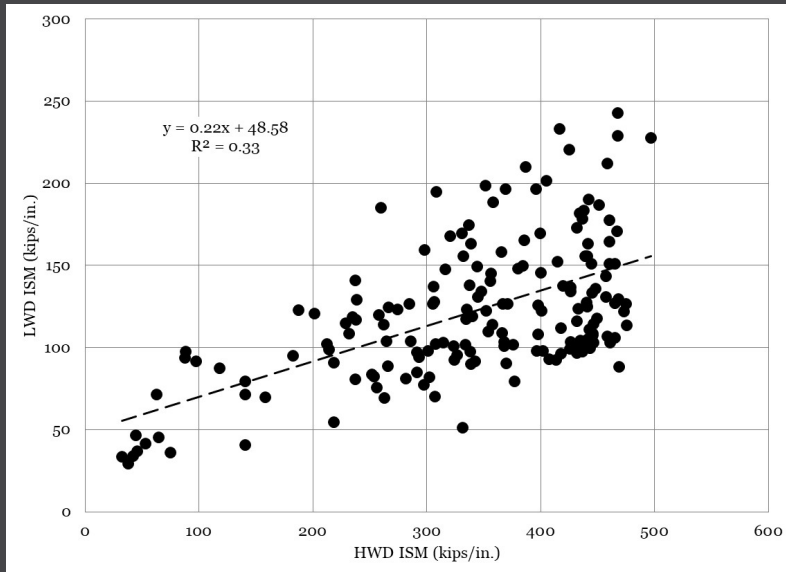
- LWD deflections were used to convert to ISM (note LWD used in this study does not have load measuring capabilities; thus constant force was assumed).
- Correlation tended to improve with lower HWD ISM (i.e., weaker pavements)

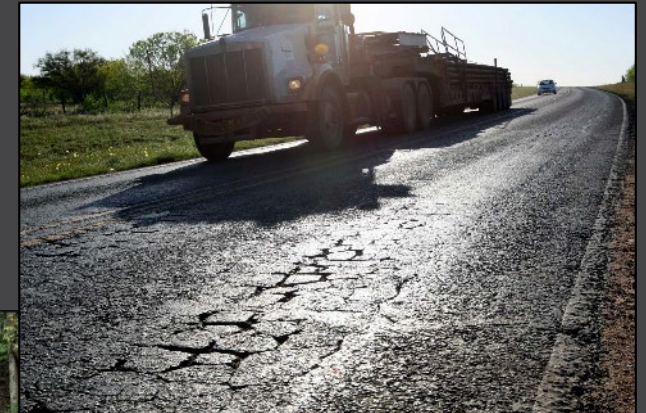
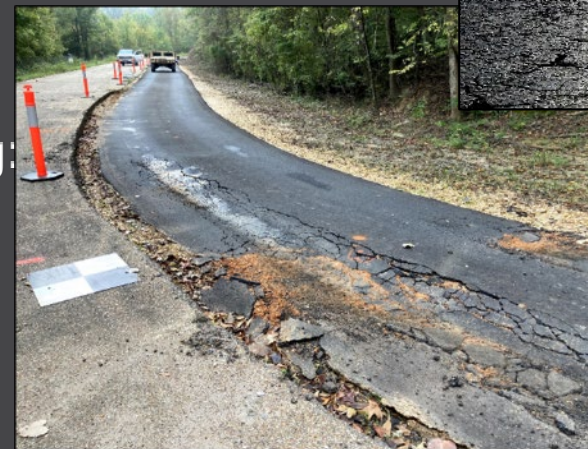
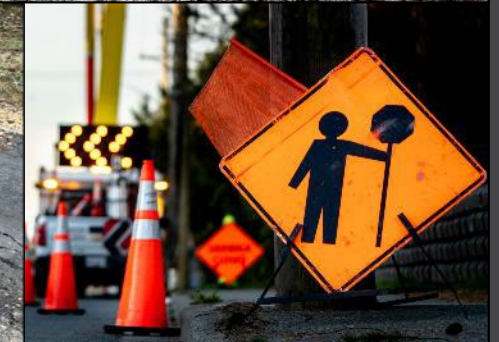
- Determine suitability of Light Weight Deflectometer (LWD) as a structural evaluation tool for LVRs.
- Explore the capability of LWD equipment in evaluating:
  - Load induced deterioration
  - Soil moisture
  - Flexible pavement temperature

- LWD was compared to FWD using Impulse Stiffness Modulus (ISM) to assess ability to track pavement structural condition.
- LWD was successful in tracking pavement structural condition over the duration of 10,000 vehicle passes (using a 4-axle, 58,000 lb truck) similar to the trends of the FWD.

- The LWD was successful in evaluating the effects of load induced deterioration on relatively weak pavement structures.

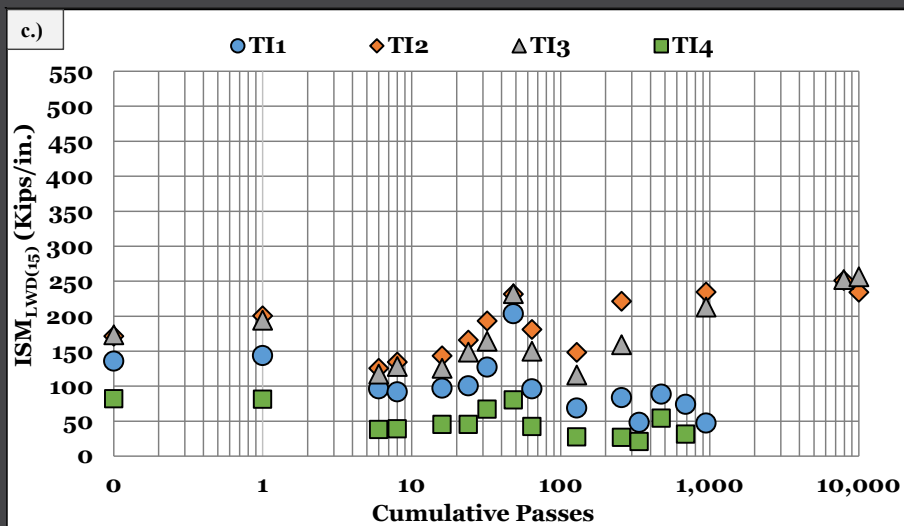
*LWD- 15kg hammer,  
150 mm plate diameter*

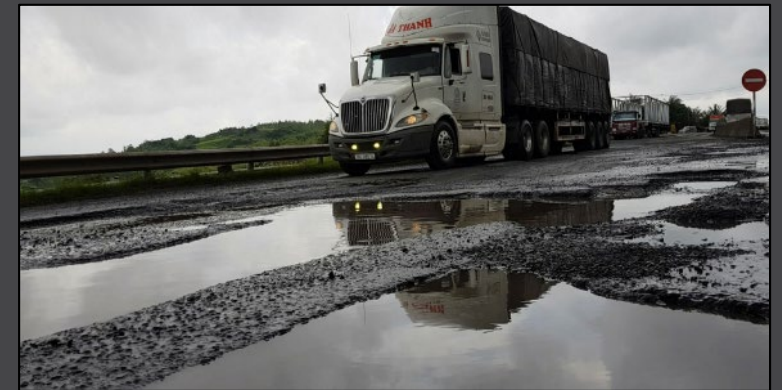
- ISMs  $> 150$  kips/in. corresponded to good pavement performance and sustained 10,000 passes or more.
- ISMs  $\leq 125$  kips/in. corresponded to poor pavement performance and sustained less than 1000 passes.
- LWD provided useful information for ISMs  $< 250$  kips/in. The LWD is not suitable for evaluating pavements stiffer than this.
